Lérida 44
Madrid

A charming building in the
heart of Madrid

Floorplans and Technical Specifications

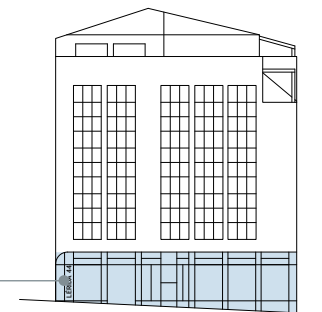
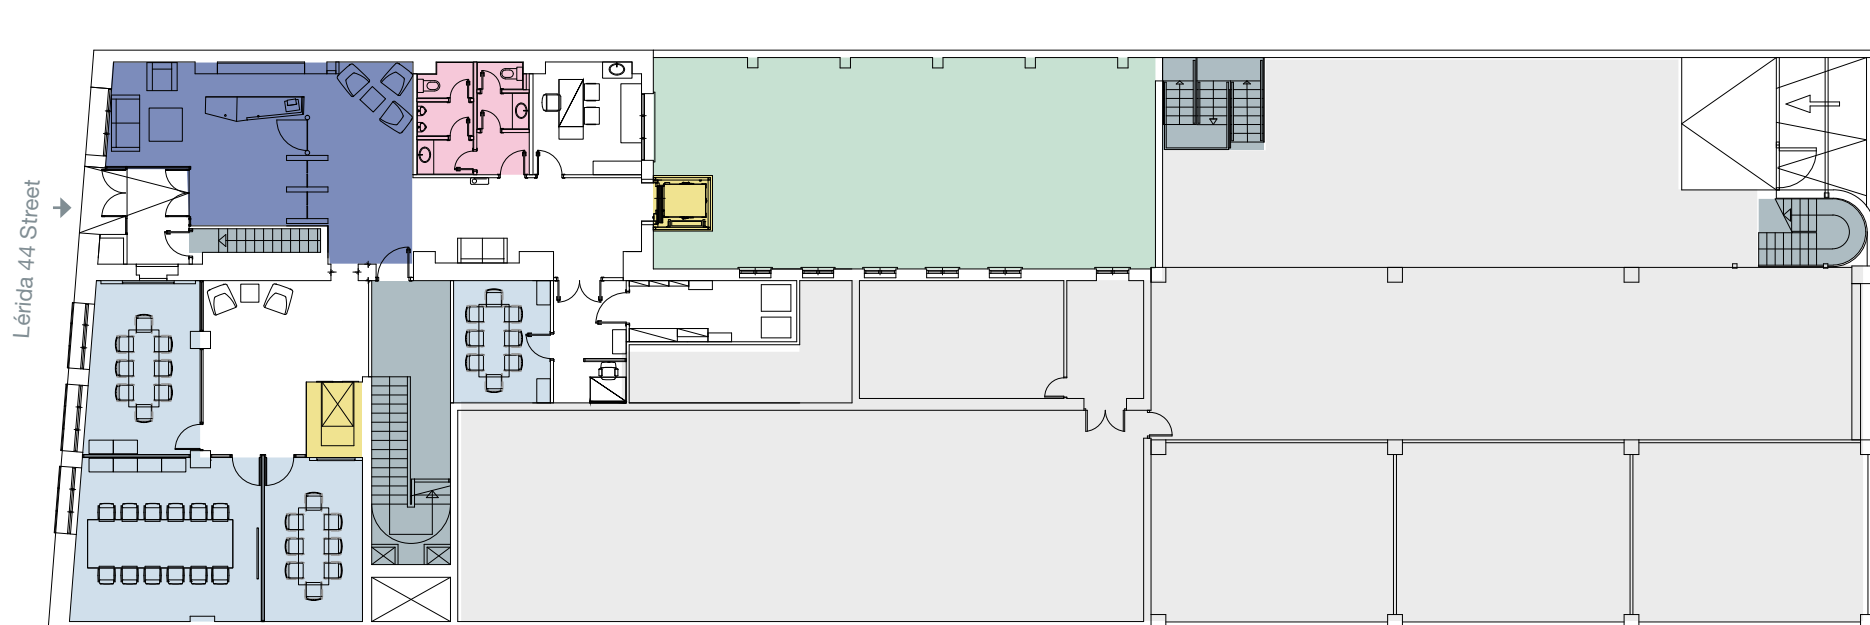
Ground Floor

● Lobby ● Meeting Room ● Terrace ● Restrooms ● Lifts ● Stairs

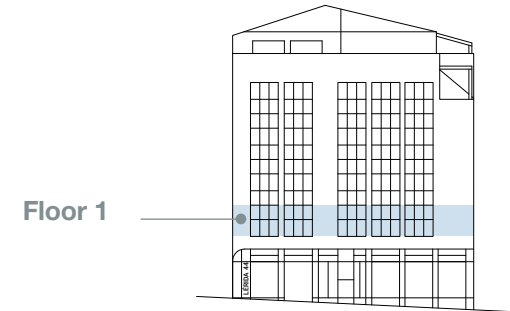
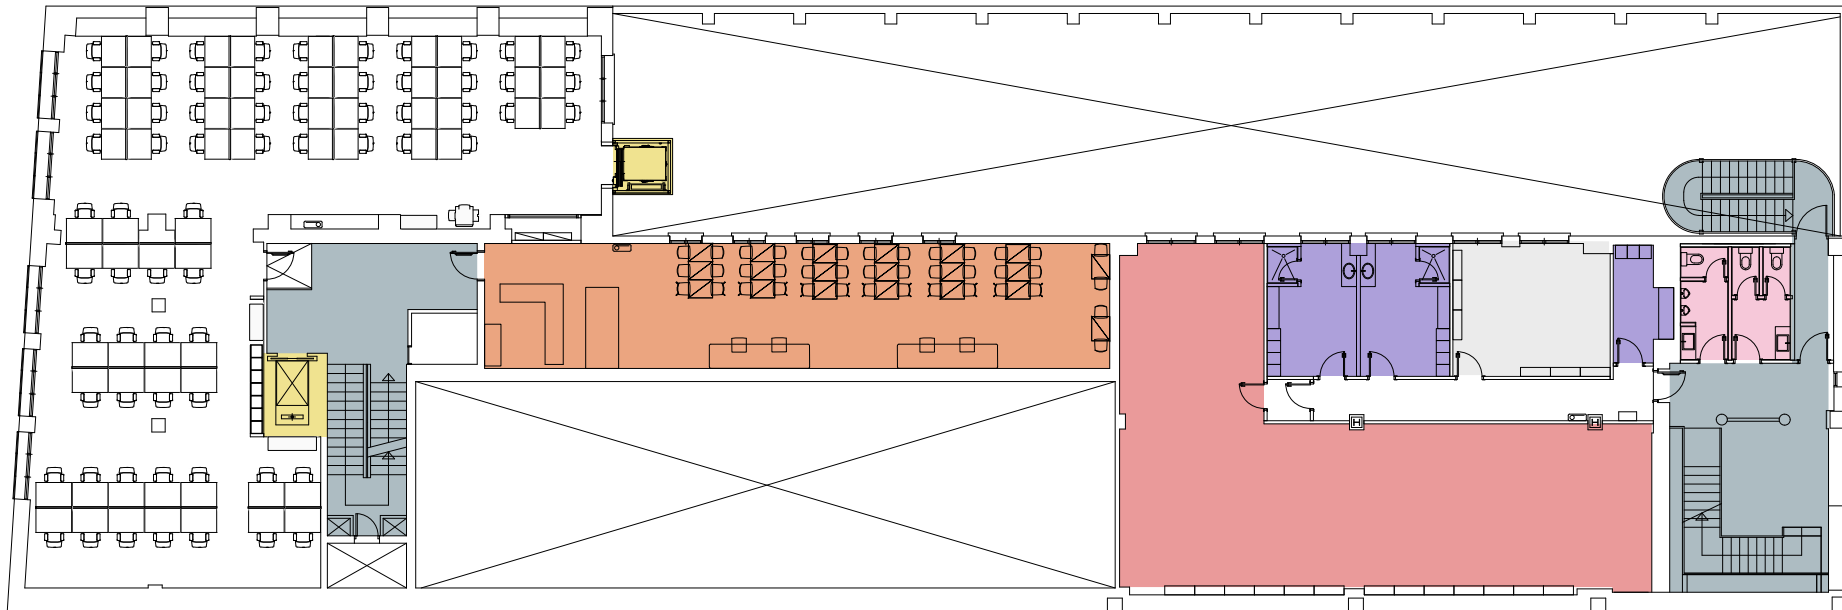
Floor 1

● Meeting Room
 ● Terrace
 ● Dining Area
 ● Multipurpose room
 ● Changing Rooms
 ● Restrooms
 ● Lifts
 ● Stairs
 ○ Offices

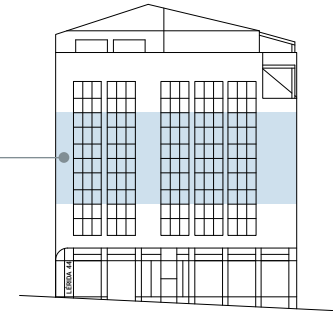
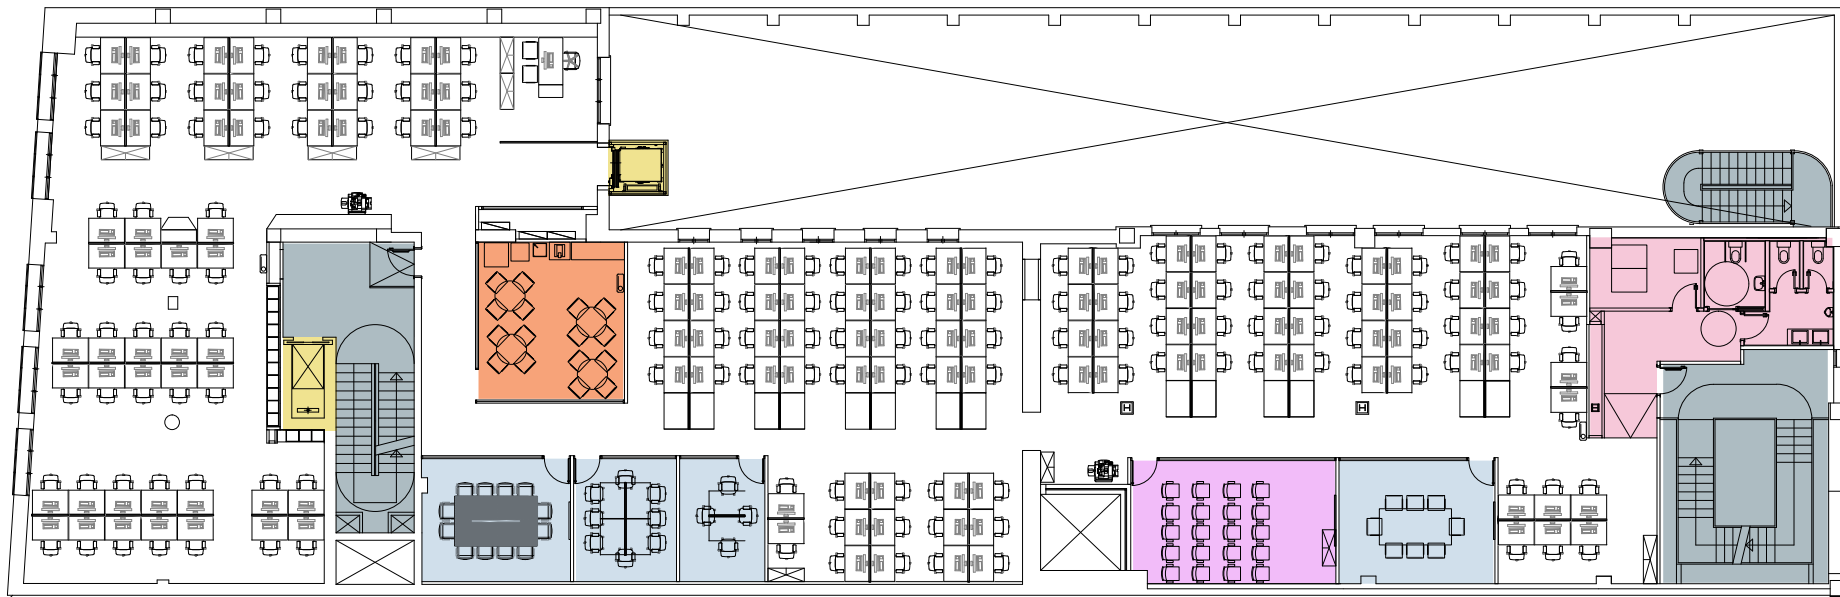
Floors 2-4

● Meeting Room ● Terrace ● Dining Area ● Auditorium ● Changing Rooms ● Restrooms ● Lifts ● Stairs ○ Offices

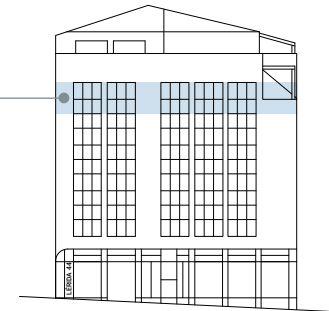
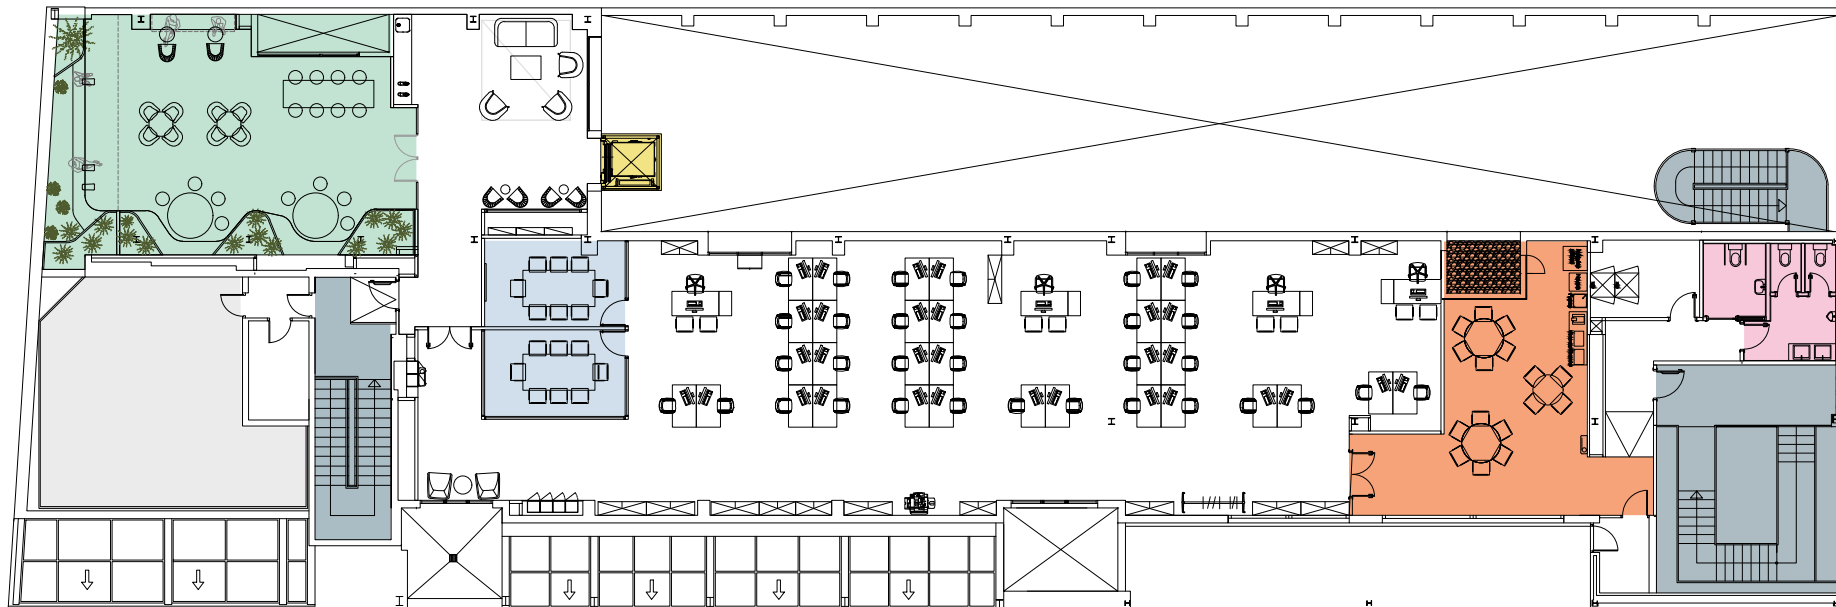
Floor 5

● Meeting Room ● Terrace ● Dining Area ● Changing Rooms ● Restrooms ● Lifts ● Stairs ○ Offices
